AERIAL PHOTOGRAPHIC ANALYSIS OF THE CHEMETCO, INCORPORATED FACILITY

Hartford, Illinois

TS-AMD-85018/85603-10
October 1985

J. S. Duggan
Environmental Programs
Lockheed Engineering and Management Services Company, Inc.
Las Vegas, Nevada 89114

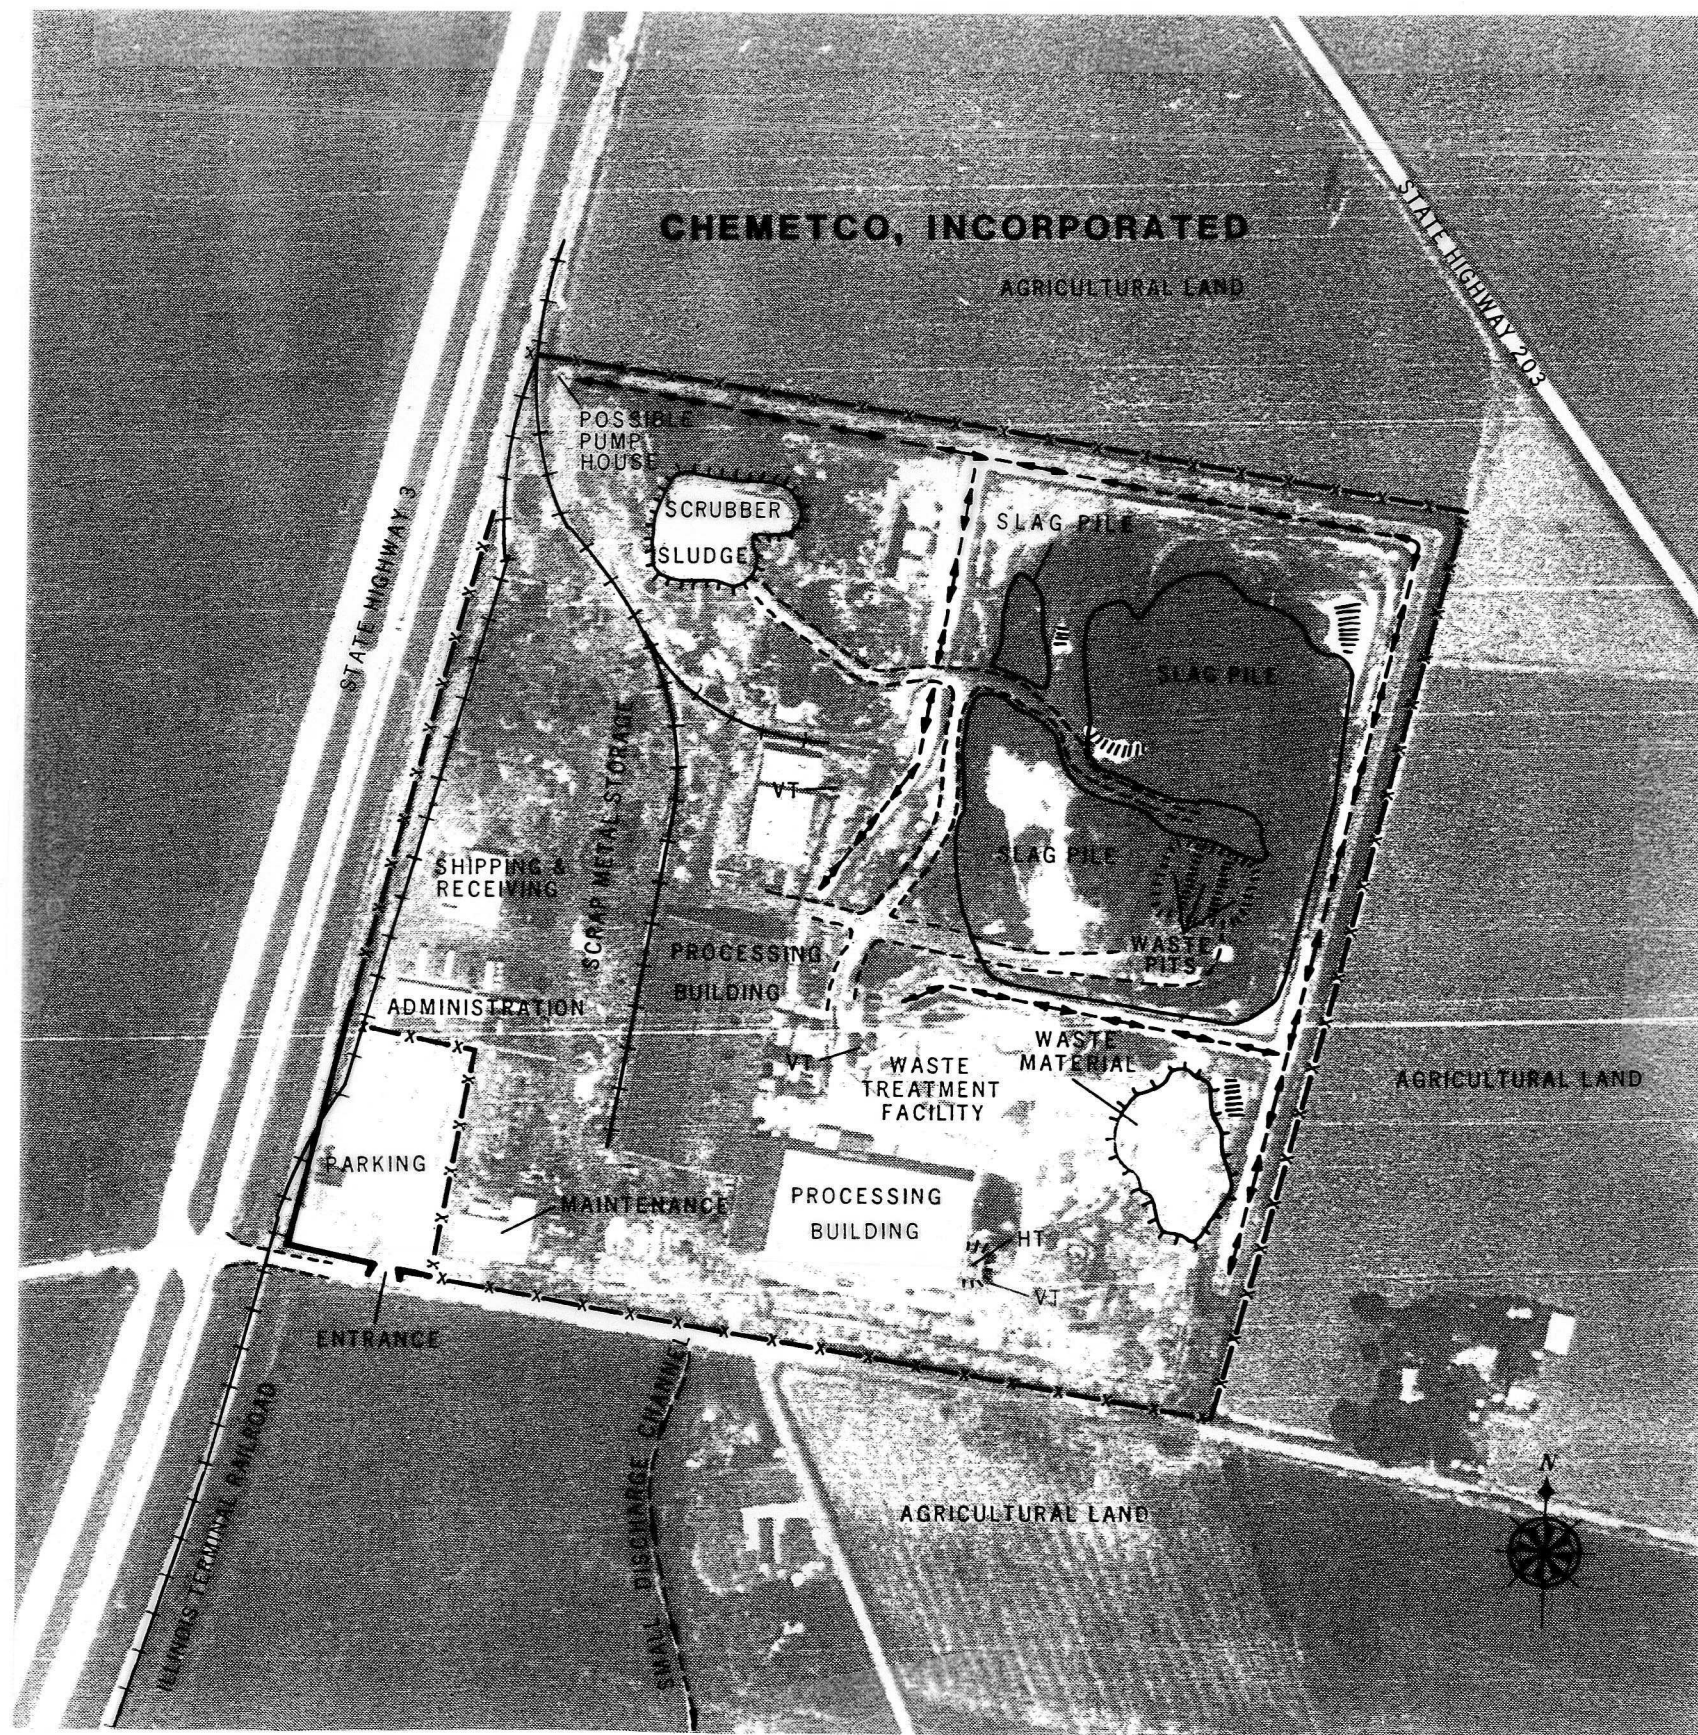
Figure 3. Chemetco, Inc., June 10, 1978. Approximate scale, 1 inch equals 275 feet.

The Chemetco facility, located two miles south of Hartford, Illinois, occupies about 40 acres adjacent to State Highway 3 and the Illinois Terminal Railroad. There are two rail spurs into the facility and a single road entrance along the south boundary. The predominate features of the site are the large slag piles, the processing buildings, a waste treatment area, two small mounds, and a 30-foot wide ditch. There are two small vertical tanks and one horizontal tank present. Only the horizontal tank appears contained.

The slag pile is about 6 acres in size in the northeast corner of the site. There are three 40 by 95 foot waste pits near the center of the pile with the dumping point at the south end of the pit. A small 0.5-acre mound of possible scrubber sludge is located in the northwest corner of the site while a similar sized pile of probable waste material can be seen in the southeast corner.

A 30-foot wide ditch extends across the north boundary and along most of the east boundary. Two other ditches extend from the center of the site to the north and to the east. A possible pump house is present at the west end of the north ditch. The flow of liquid in the ditches cannot be determined as there are no indications such as slope or wave action. A portion of the liquid is very light in tone indicating the possible presence of contaminants. The total length of all the ditches is 3,535 feet.

A single small drainage channel is evident in a field south of the site which may be used for discharge of waste liquid from the site. This channel is connected to Long Lake.

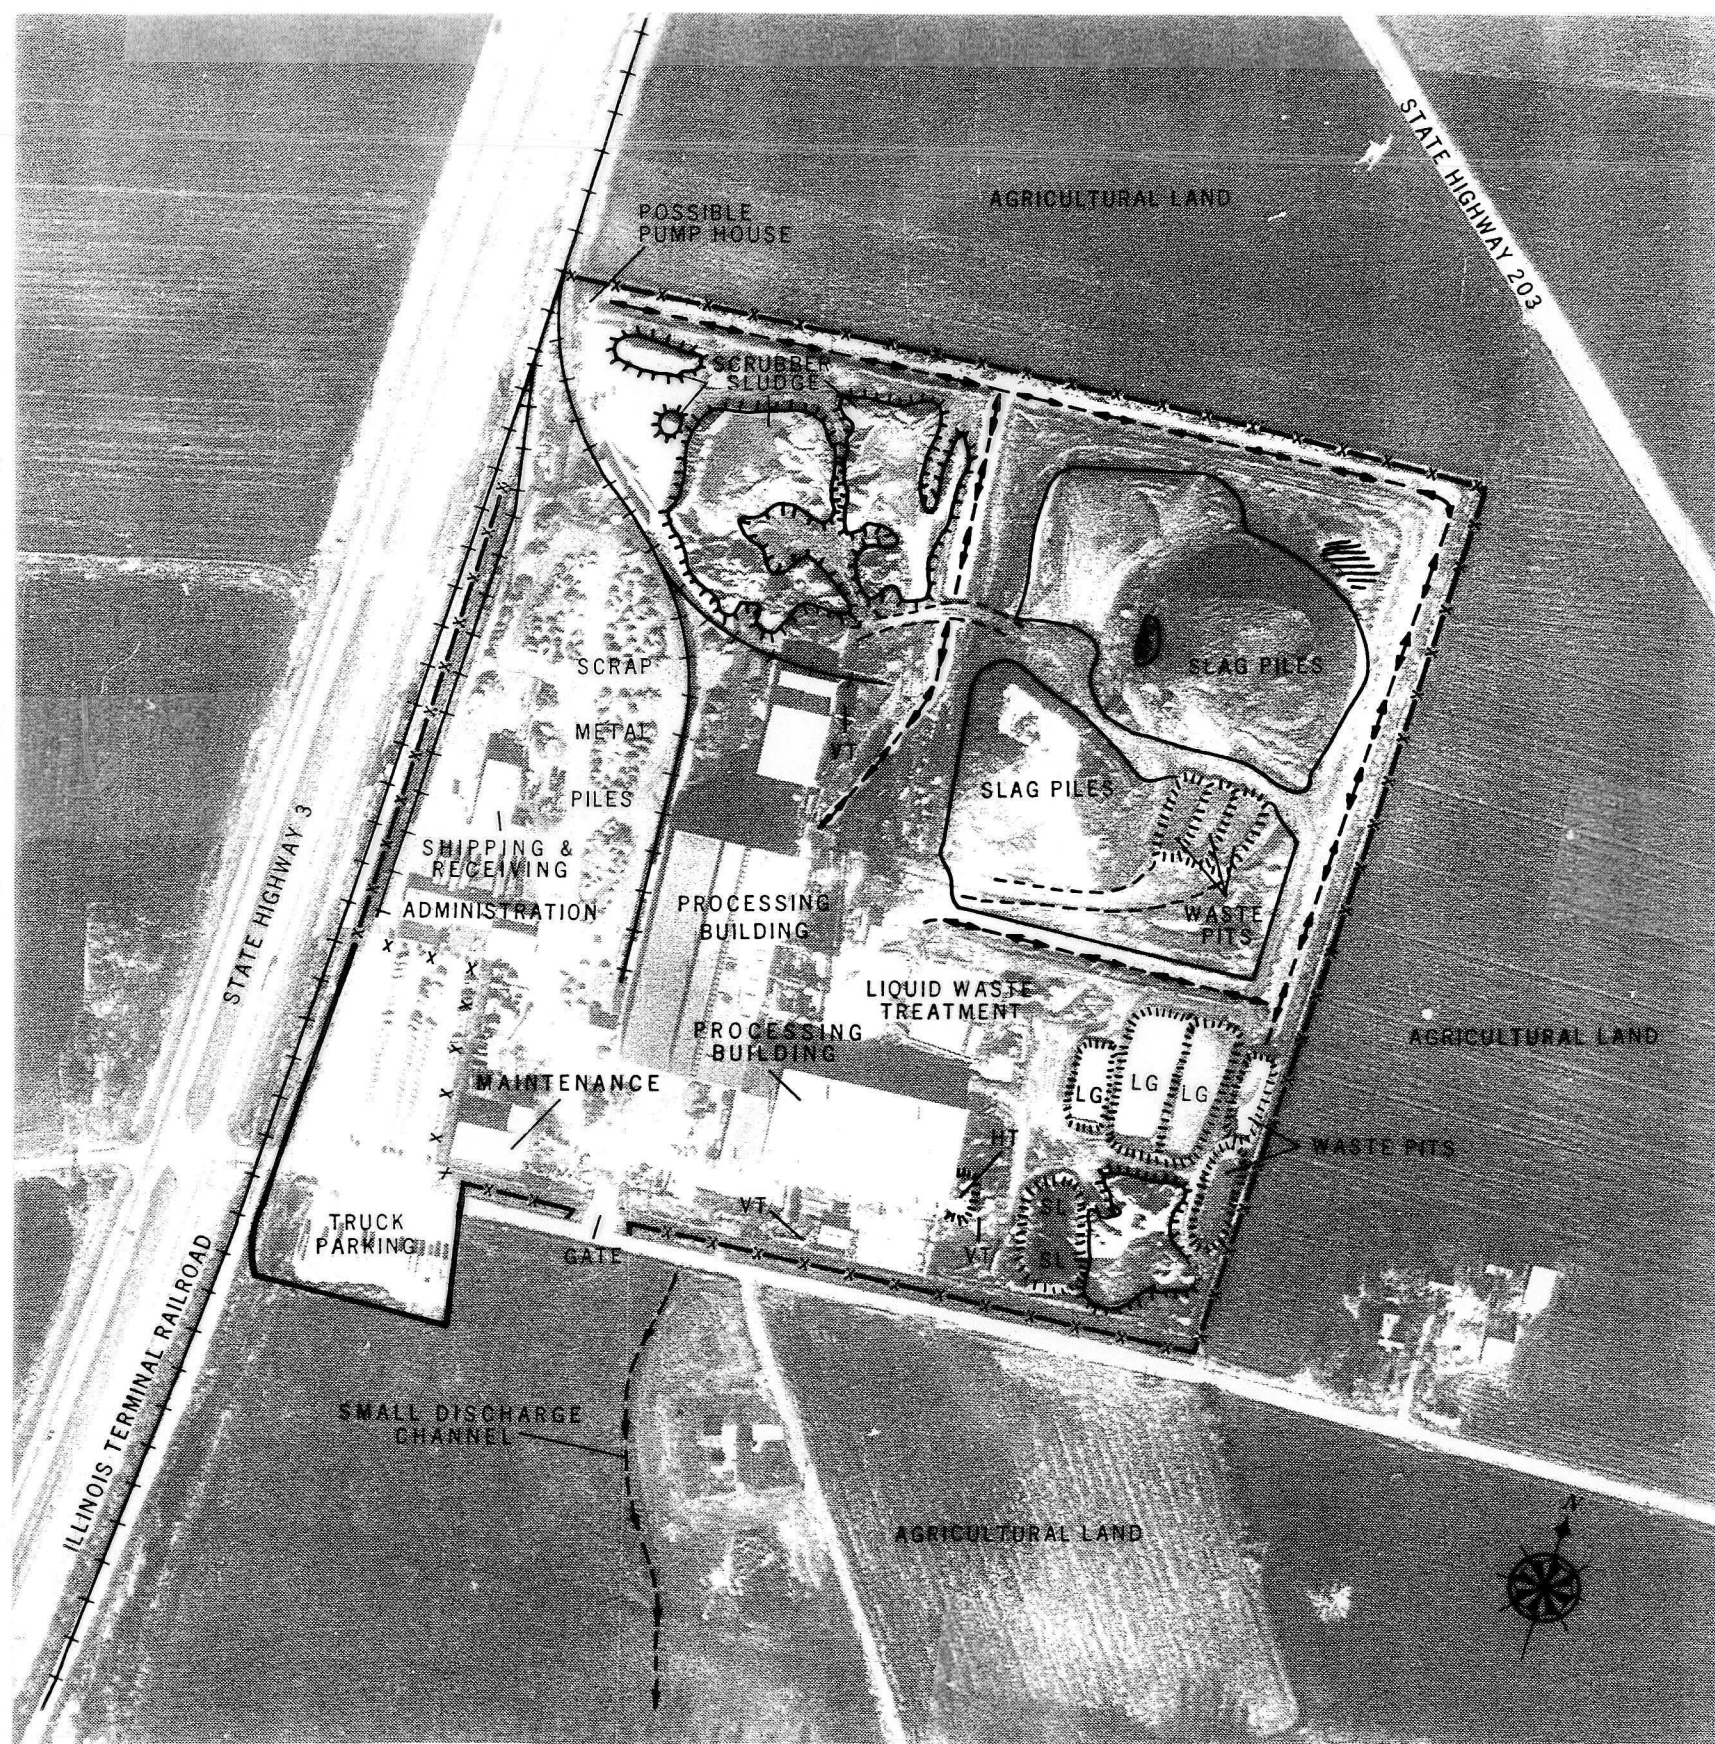
Figure 4. Chemetco, Inc., December 14, 1980. Approximate scale, 1 inch equals 275 feet.

Analysis of the 1980 photographs reveal only a very small increase in size in the site but some significant changes within the site. In the southwest corner across the road which is the south boundary of the site fill material has been brought in to create a truck parking area. This area is about one acre in extent so the facility now is about 41 acres.

Within the site the slag piles in the northeast corner are slightly larger and higher. The three waste pits are still present and appear to contain some waste material. The scrubber sludge pile in the northwest corner is much larger indicating continued processing activity at the site. In the southeast corner of the site three lagoons have been built. The largest of these is approximately 220 by 80 feet while the smallest is 110 by 55 feet. A portion of the adjacent ditch has been converted into two waste pits eliminating approximately 275 feet of the ditch. Both of these pits contain waste material. To the south of the lagoons there is a mound of material and an adjacent pool of liquid which is surrounded by a dike. A third vertical tank is present but does not appear to be contained.

The remainder of the site appears much as it did in 1978 with the exception of the prominent new entrance along the south boundary. The small discharge channel is still present but it is not possible to confirm if any liquid is present.

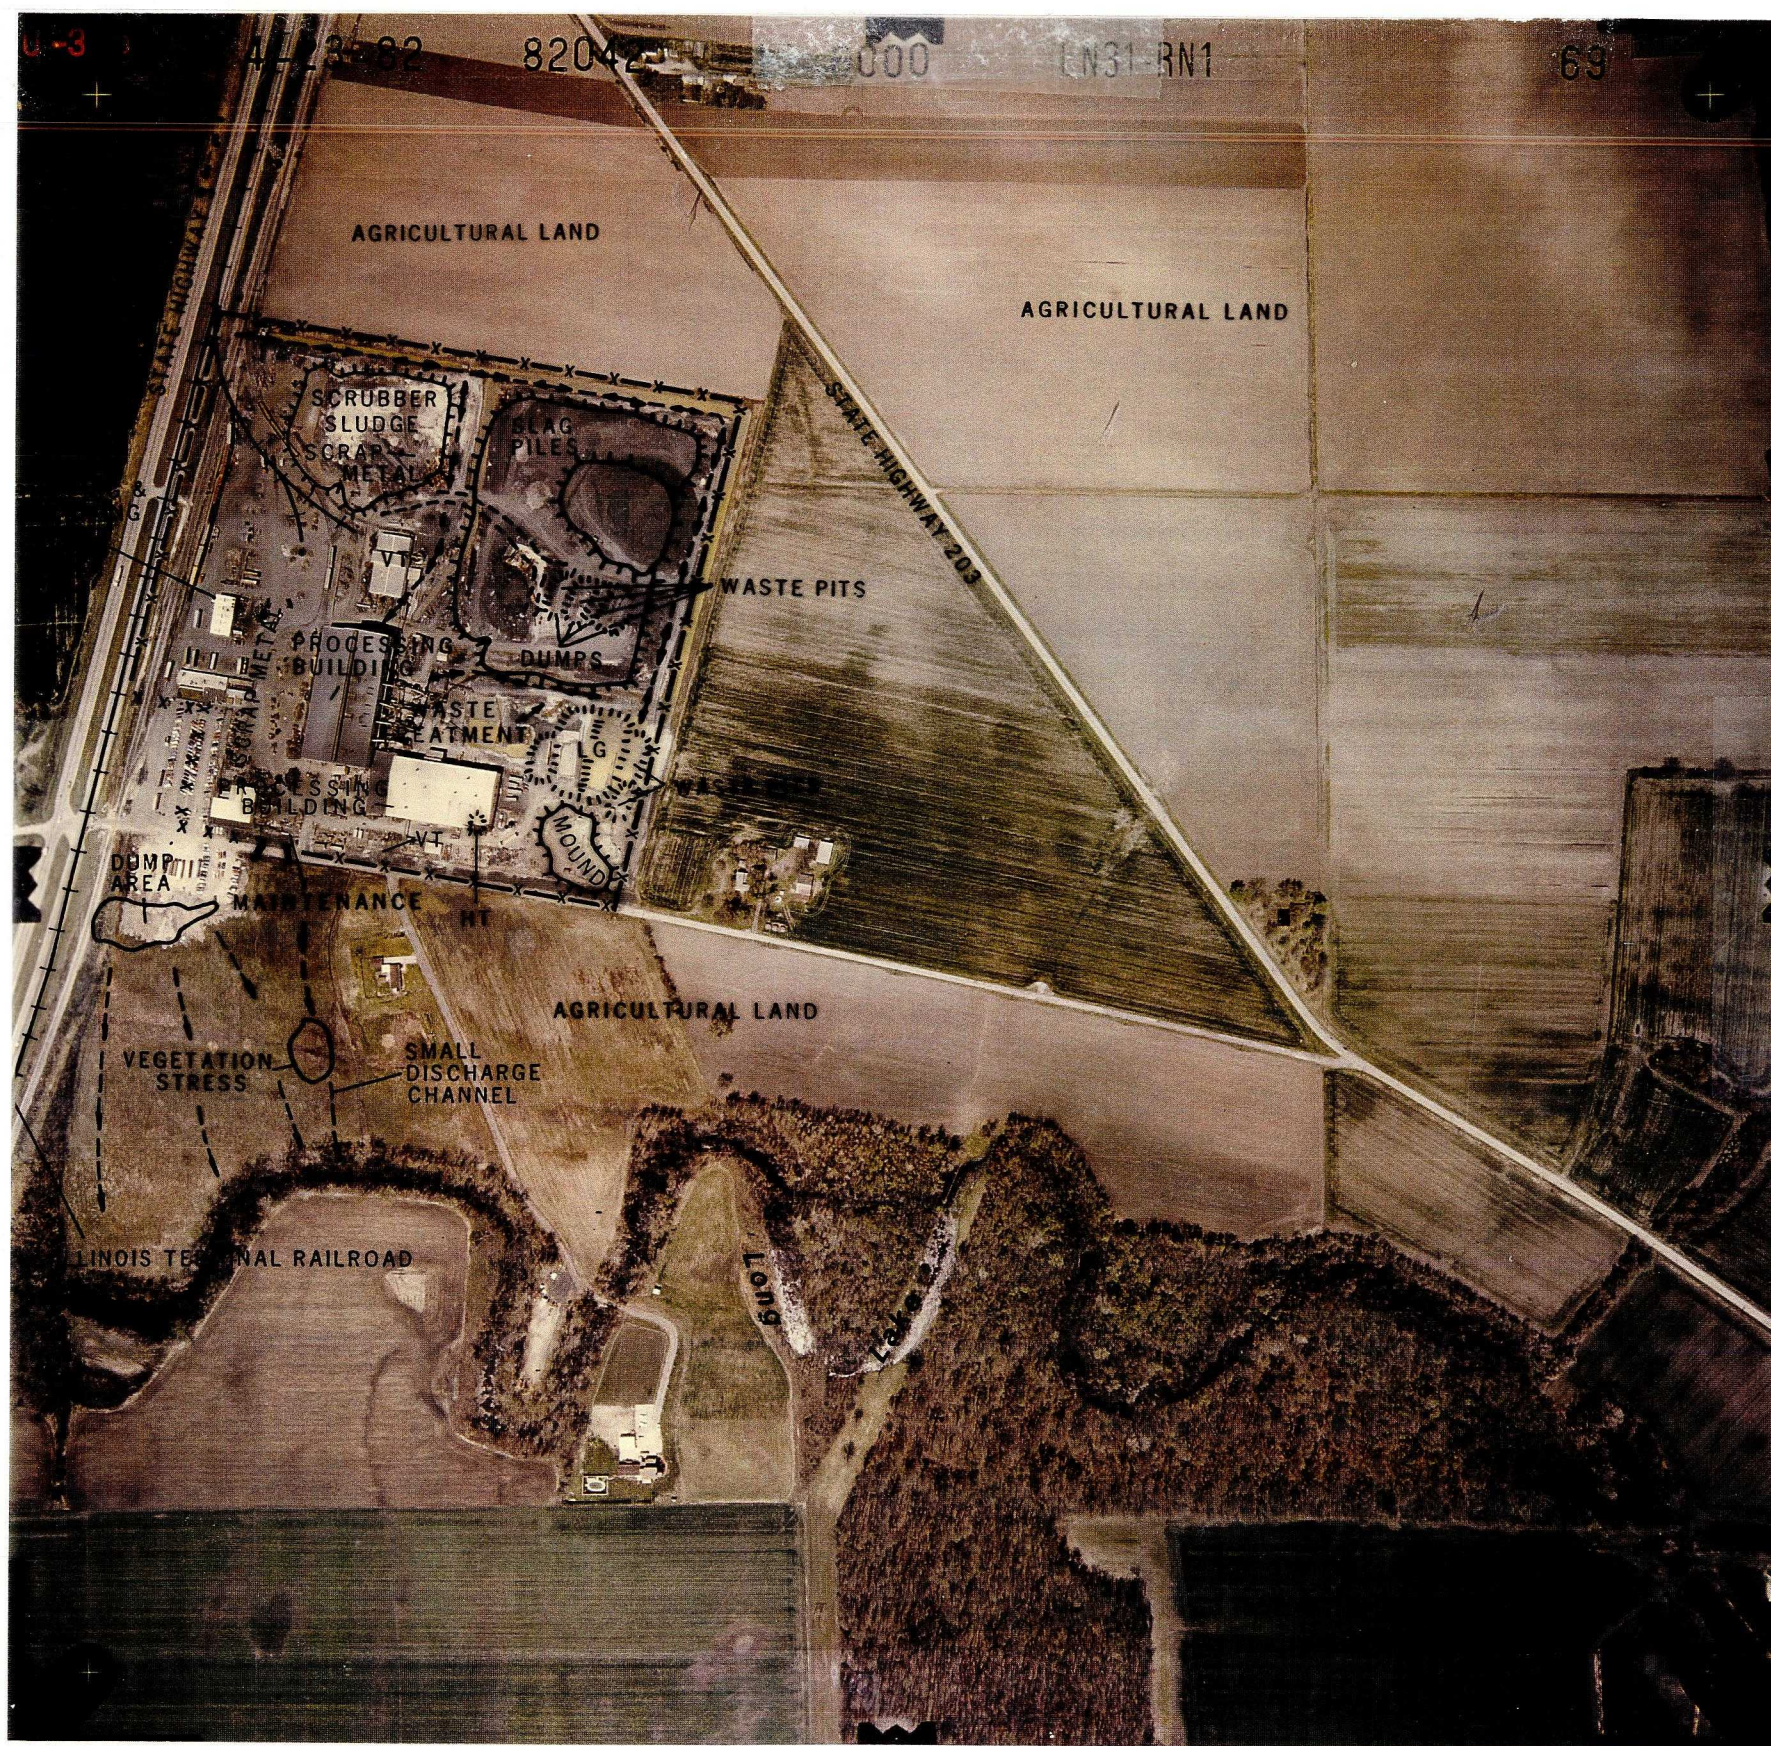
Figure 5. Chemetco, Inc., April 23, 1982. Approximate scale, 1 inch equals 500 feet.

Analysis of the color aerial photographs reveal several small changes in the overall appearance of the site. The slag piles have grown in size to about 8 acres while the scrubber sludge piles are about 2.6 acres. A fourth waste pit has been added in the slag pile area but it appears to be open at the north end.

The waste lagoons all contain liquid while the two adjacent waste pits appear full. The mound present in 1980 is slightly smaller in 1982 and the adjacent pool of liquid has either been removed or has been covered over. The shipping/receiving area, the processing buildings, waste treatment area, and the maintenance area remain the same as in 1980.

The area south of the main facility that was a parking lot area has been expanded by about 1 acre and appears to be used for dumping of waste material. Drainage from this dump area is south toward Long Lake. A small area (150 by 100 feet) adjacent to the discharge channel appears to have suffered some vegetation stress.

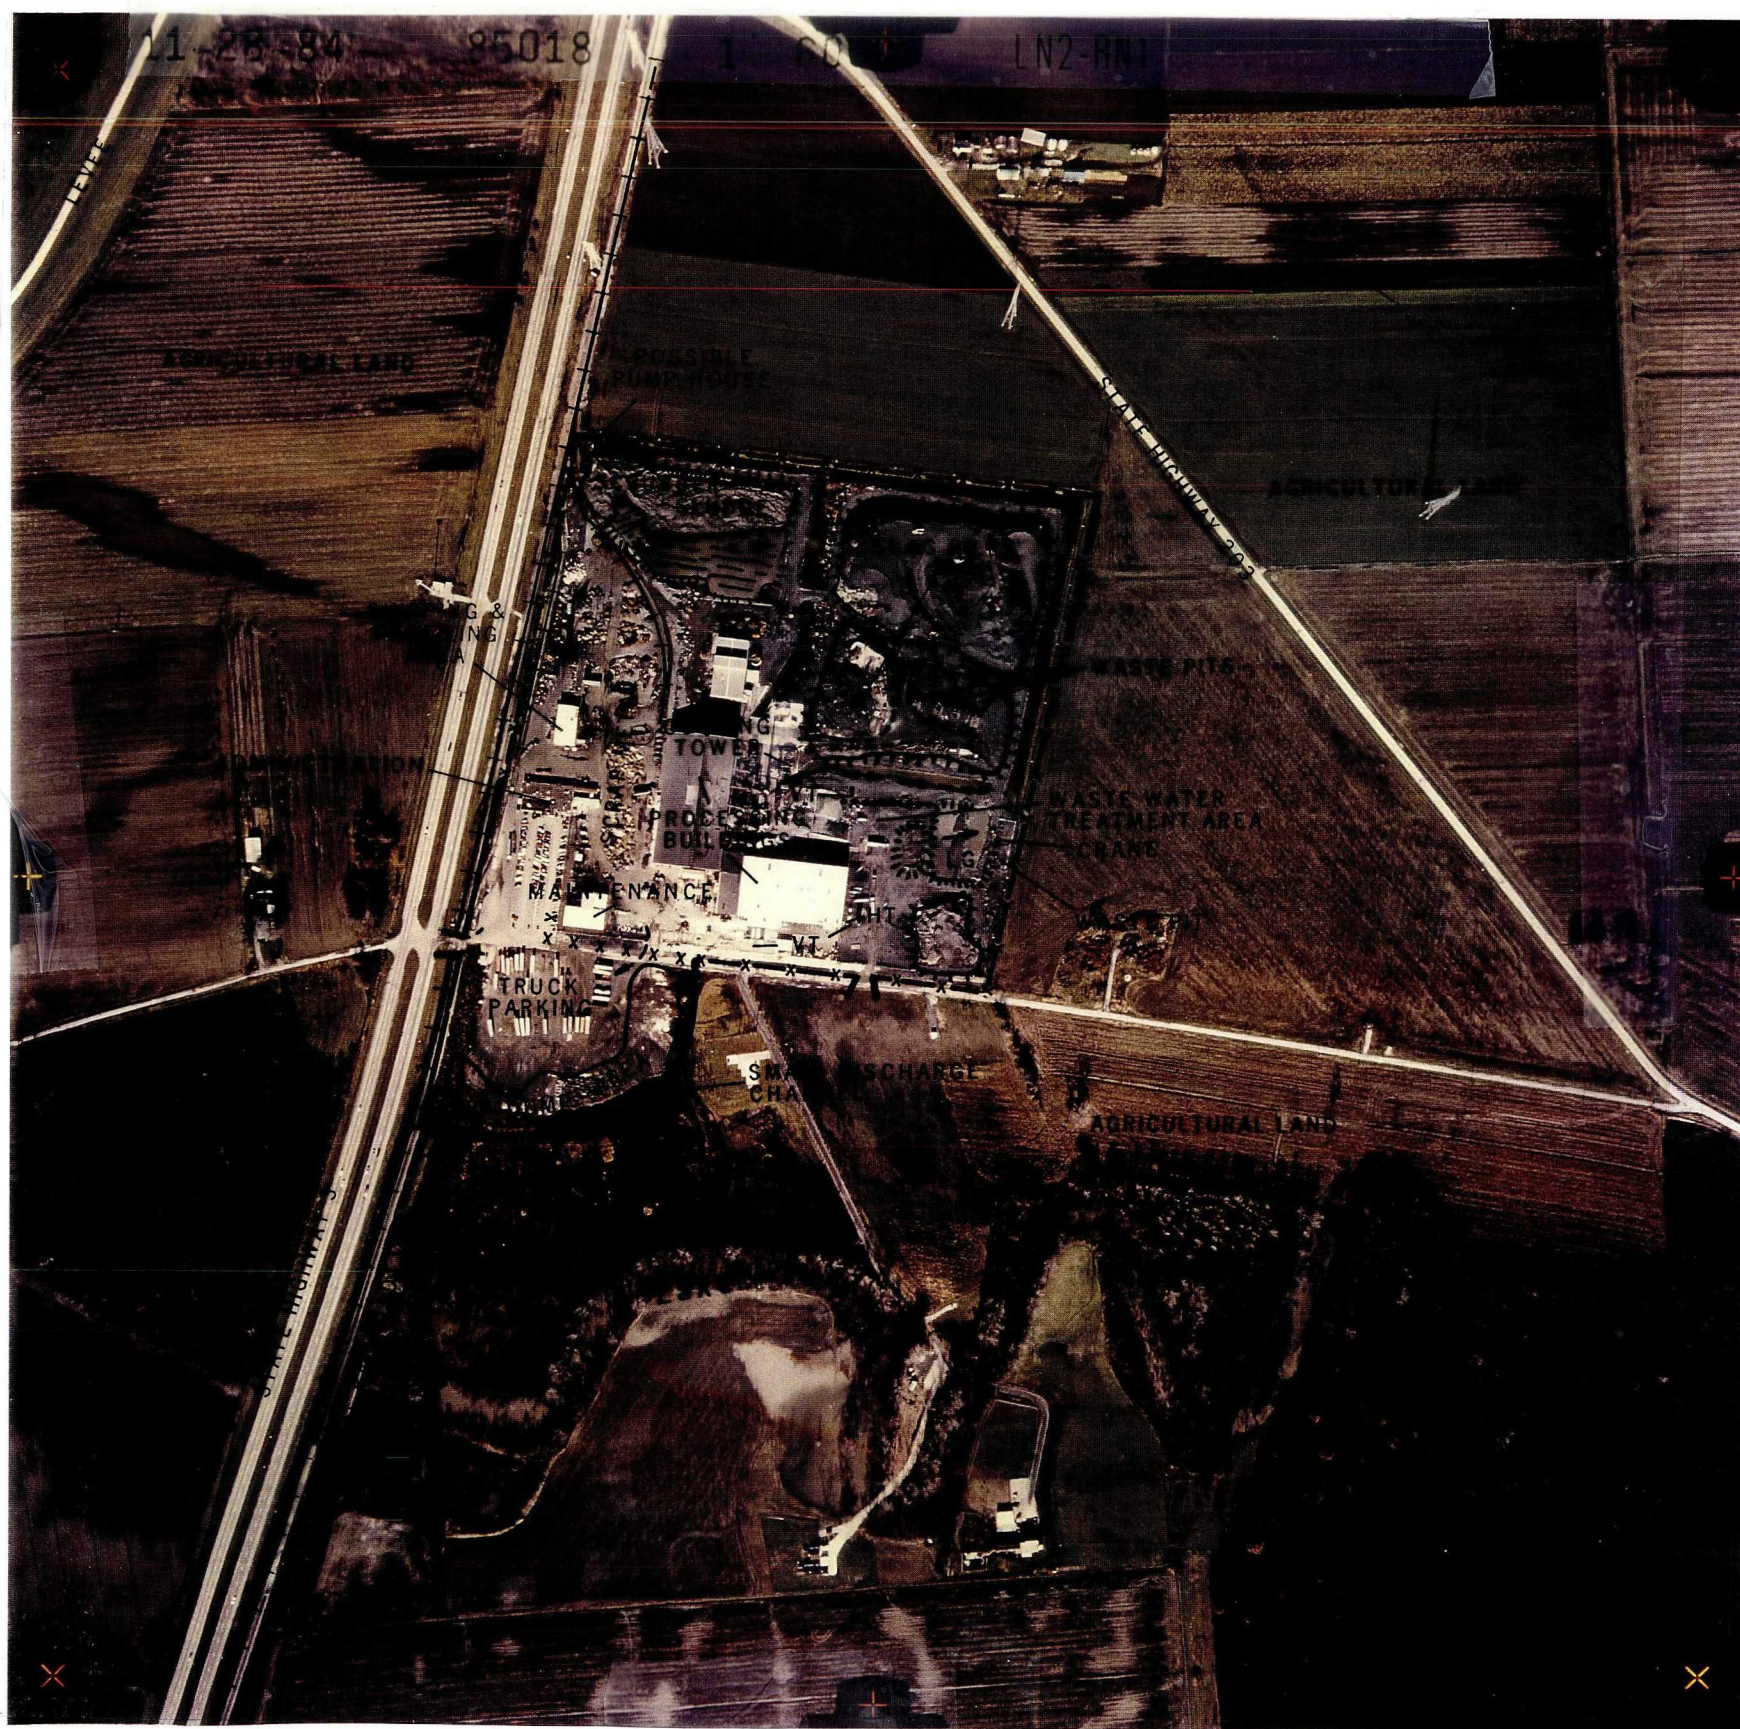
Figure 6. Chemetco, Inc., November 28, 1984. Approximate scale, 1 inch equals 500 feet.

The color aerial photographs of November 28, 1984, reveal continued activity at the Chemetco facility. There appears to be more scrap piles in the shipping and receiving area. The scrubber sludge piles have grown and two bodies of liquid are visible. These pools of liquid total about 1.35 acres. The slag piles remain much the same as in 1982 and there are still four waste pits within the piles.

In the southeast corner the large lagoon still contains liquid but the smaller lagoon now appears to be filled with solid material. The two waste pits east of the lagoons appear full but it appears from the presence of an excavation crane that one of the pits is being emptied. Near the center of the site adjacent to the processing building and the waste treatment area, there are two cooling towers constructed since the overflight of 1982.

The dump area to the south of the site has been expanded further out into the adjacent field. This adds another 3 acres to the site, increasing the overall site size to about 45 acres. The different tones of the material in the dump indicates a variety of wastes are present. Drainage from this area is toward the south and Long Lake.
